Case History – Revision of Failed Total Ankle Replacement to Fusion with Meshworks Cage.

HG Davies, MB Davies.

Sheffield Teaching Hospitals NHS Trust

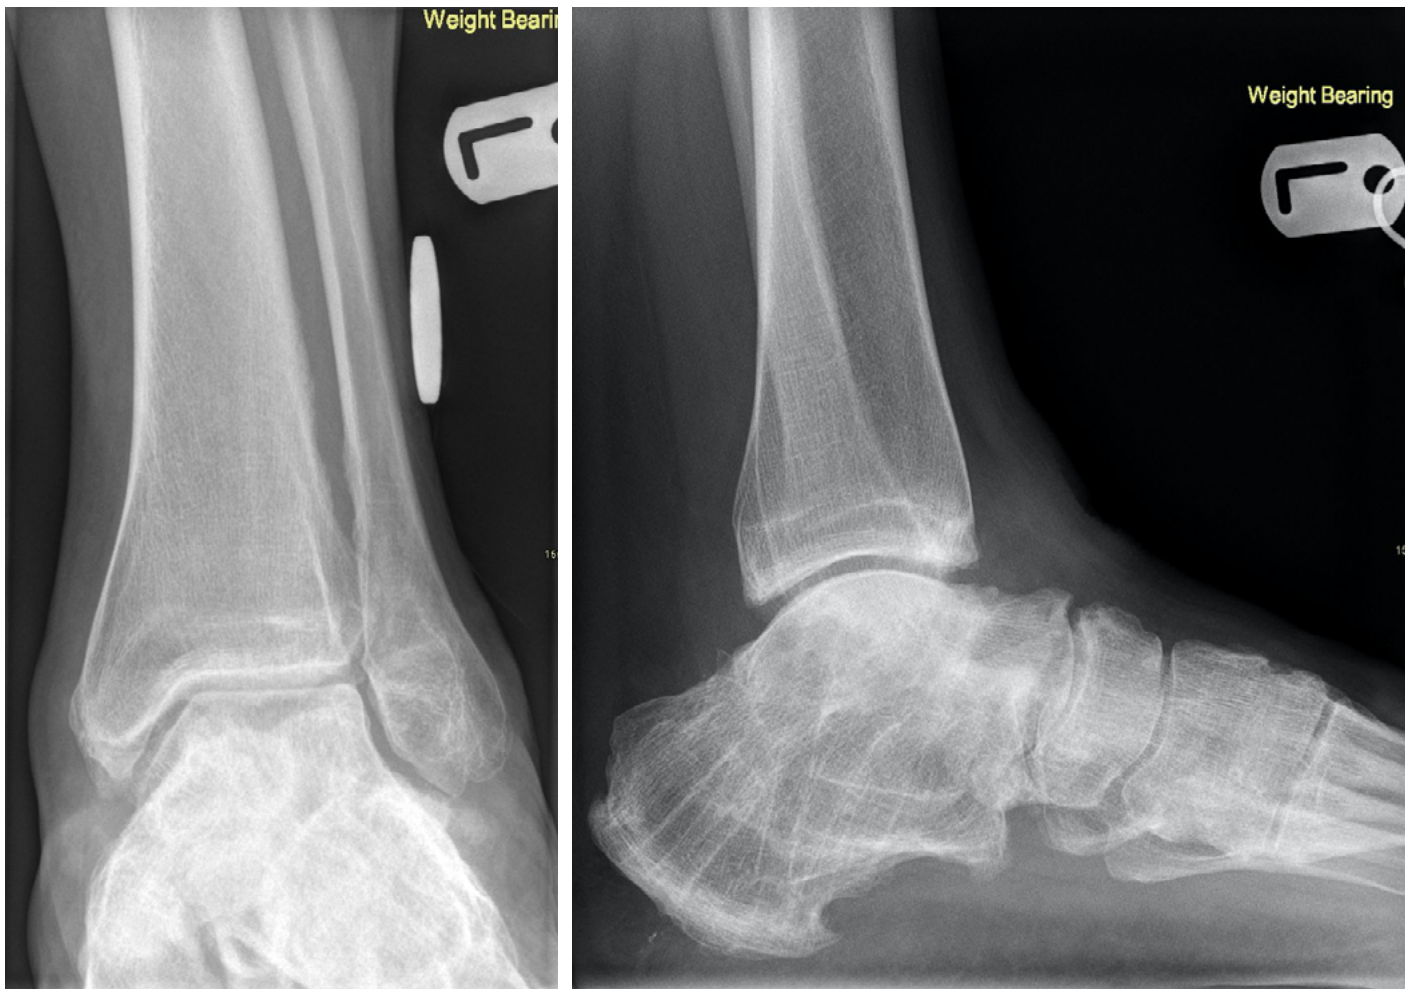
She had a significant history having sustained a closed left calcaneal fracture in 2012 which was treated by open reduction and internal fixation that had become infected. After removal of metalwork, she underwent a subtalar fusion owing to ongoing pain. This failed to unite and so, in 2016, a further attempt at fusing this joint was undertaken achieving union with no further history of infection. However, since this surgery, she had persistent pain around the hindfoot which differed in its character from the pain prior to the subtalar fusion. Examination revealed a quiescent soft tissue envelope and well healed surgical scars. Tenderness was elicited around the ankle joint line. Radiographs revealed early arthrosis within the ankle joint (Figure 1).

Figure 1 - AP and lateral plain radiographs

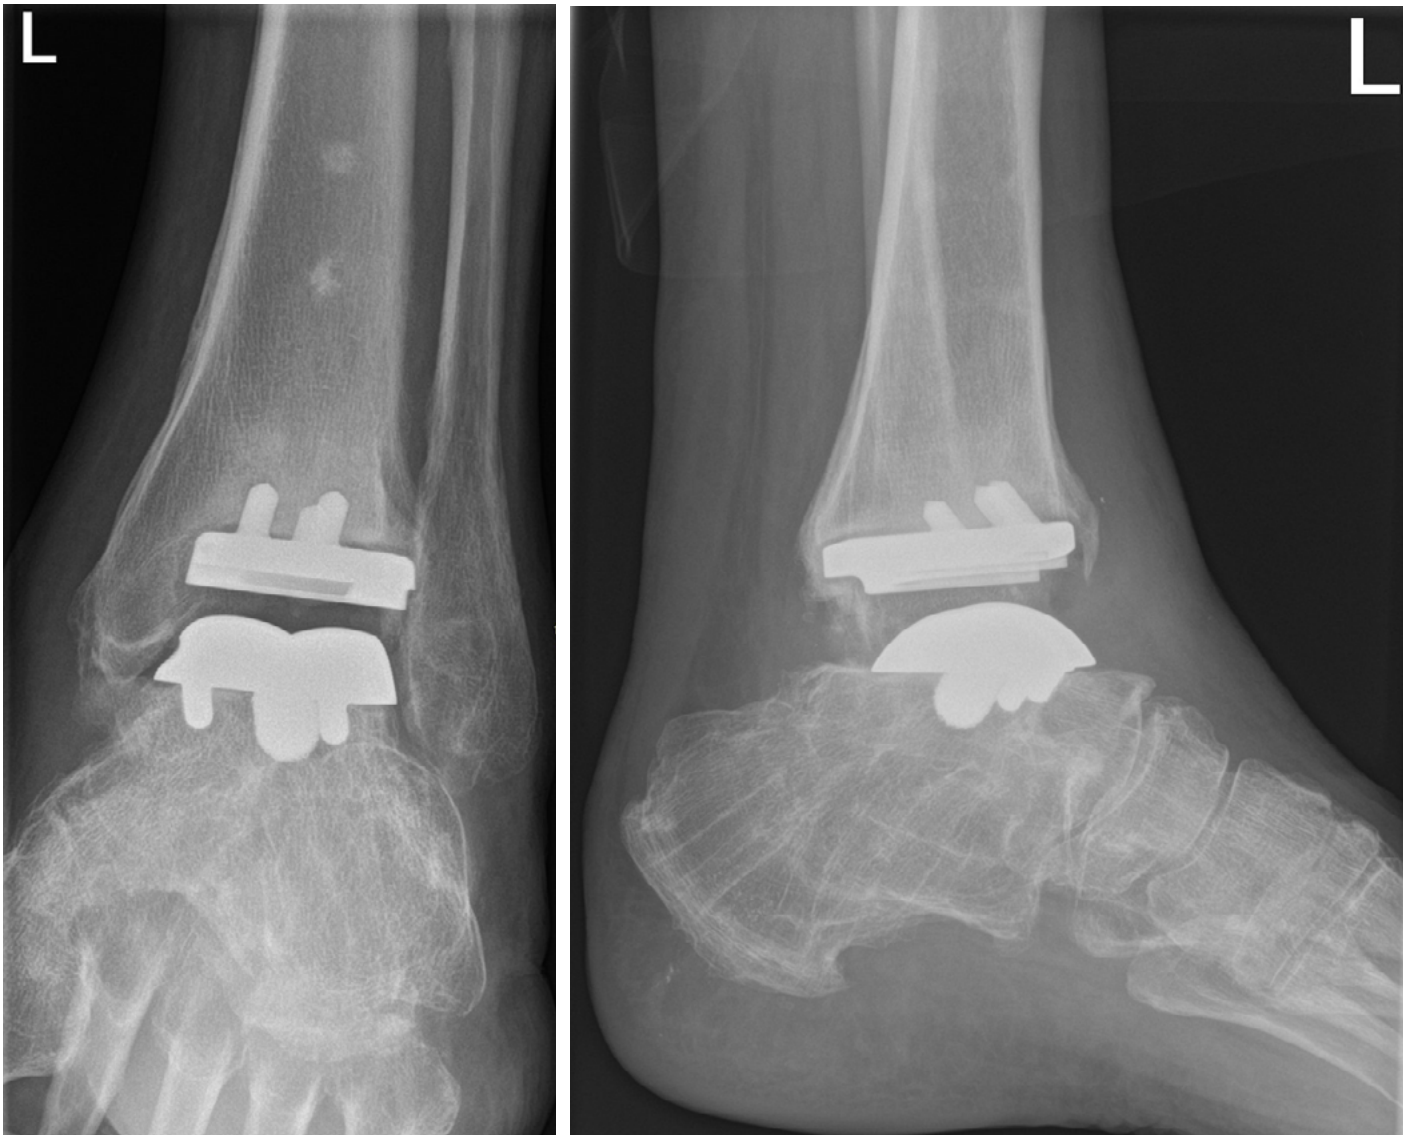
Figure 2 - Plain films post total ankle replacement

Unfortunately, six months after the TAR surgery, the patient remained in a great deal of pain with persistent swelling. There had been no history of wound issues. Plain radiographs did not provide a clear reason for these symptoms but there was some concern on a postoperative CT scan that the tibial component was showing early signs of loosening, raising the possibility of an indolent bacterial infection. Aspiration of the TAR did not reveal any organisms and a year after TAR implantation, given the severity of symptoms, plans were made to remove the TAR and treat for an undiagnosed deep infection. The TAR was removed and a gentamicin-impregnated cement spacer was inserted into the void.

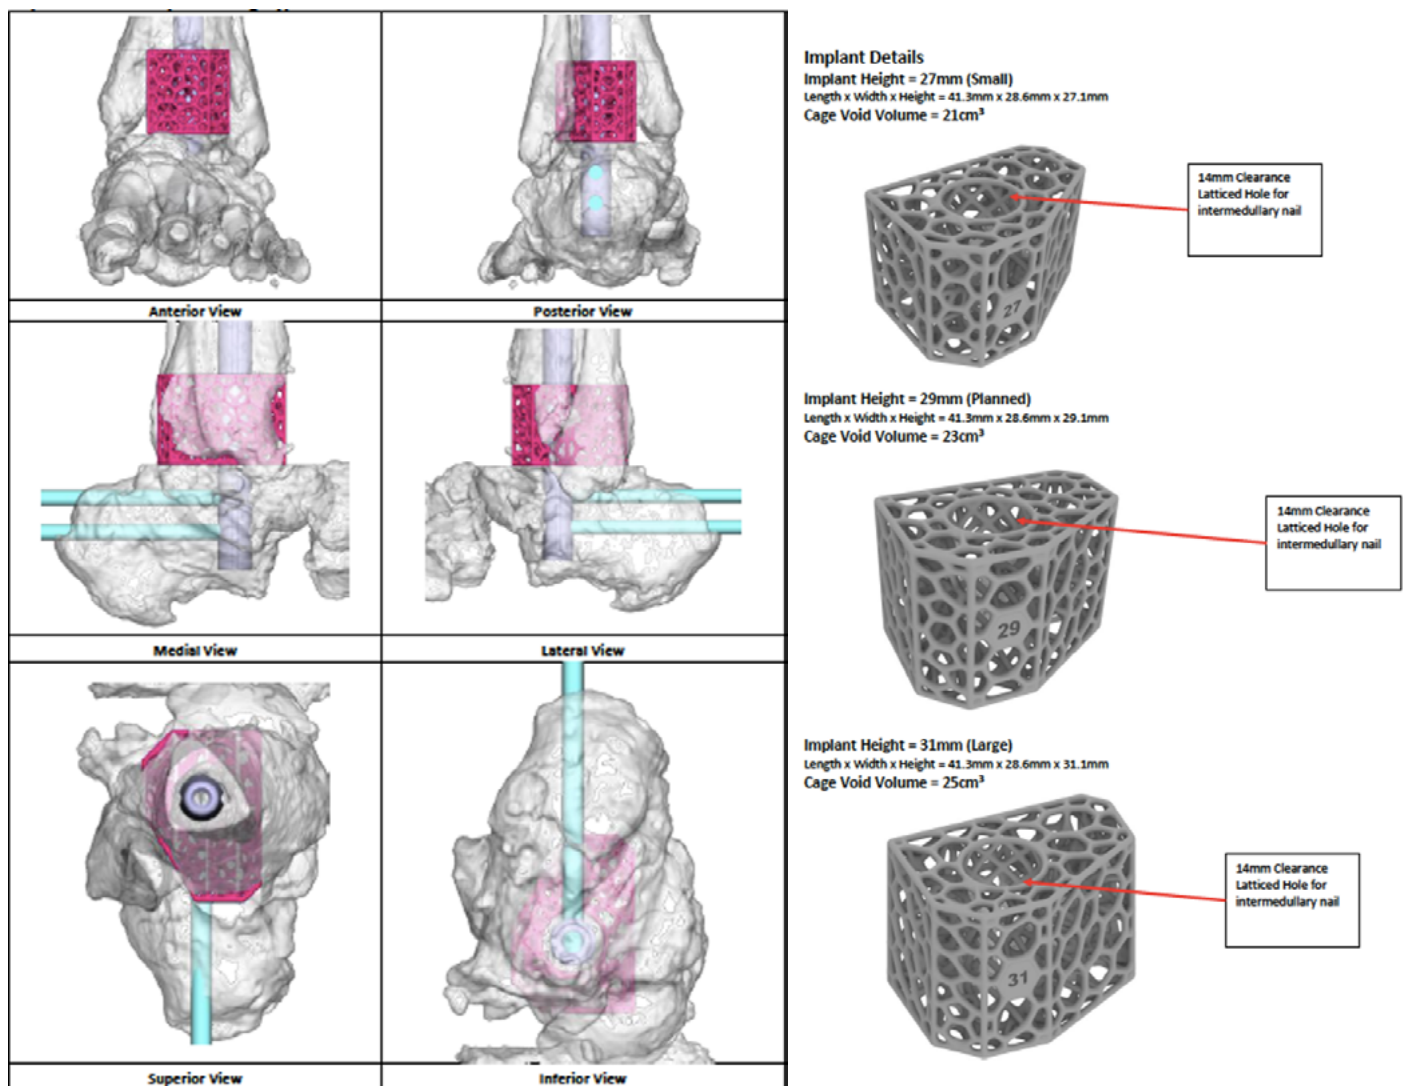
With the TAR explanted, the soft tissues healed well and some of the patient's pain was alleviated. No growth of organisms was identified from the intra-operative samples. The patient was keen to pursue further surgery to achieve greater pain relief and plans were made to convert the pseudarthrosis to an arthrodesis using a custom cage to fill the void. CT imaging was used to delineate the extent of the bone void and this was used to devise a surgical treatment plan (Figure 3). Through the previously utilised anterior approach to the ankle, a custom cage was designed with a central cannulation to secure it with the Oxbridge hindfoot nail. It was intended to fill the cage with bone graft and Cerement G to cover for any possible residual deep infection.

Figure 3 - the planned cage implant and Oxbridge hindfoot nail

The implant was designed to be implanted utilising the previous anterior approach for implantation and explantation of the TAR. The cement spacer was removed piecemeal and samples were taken for microbiological assessment.

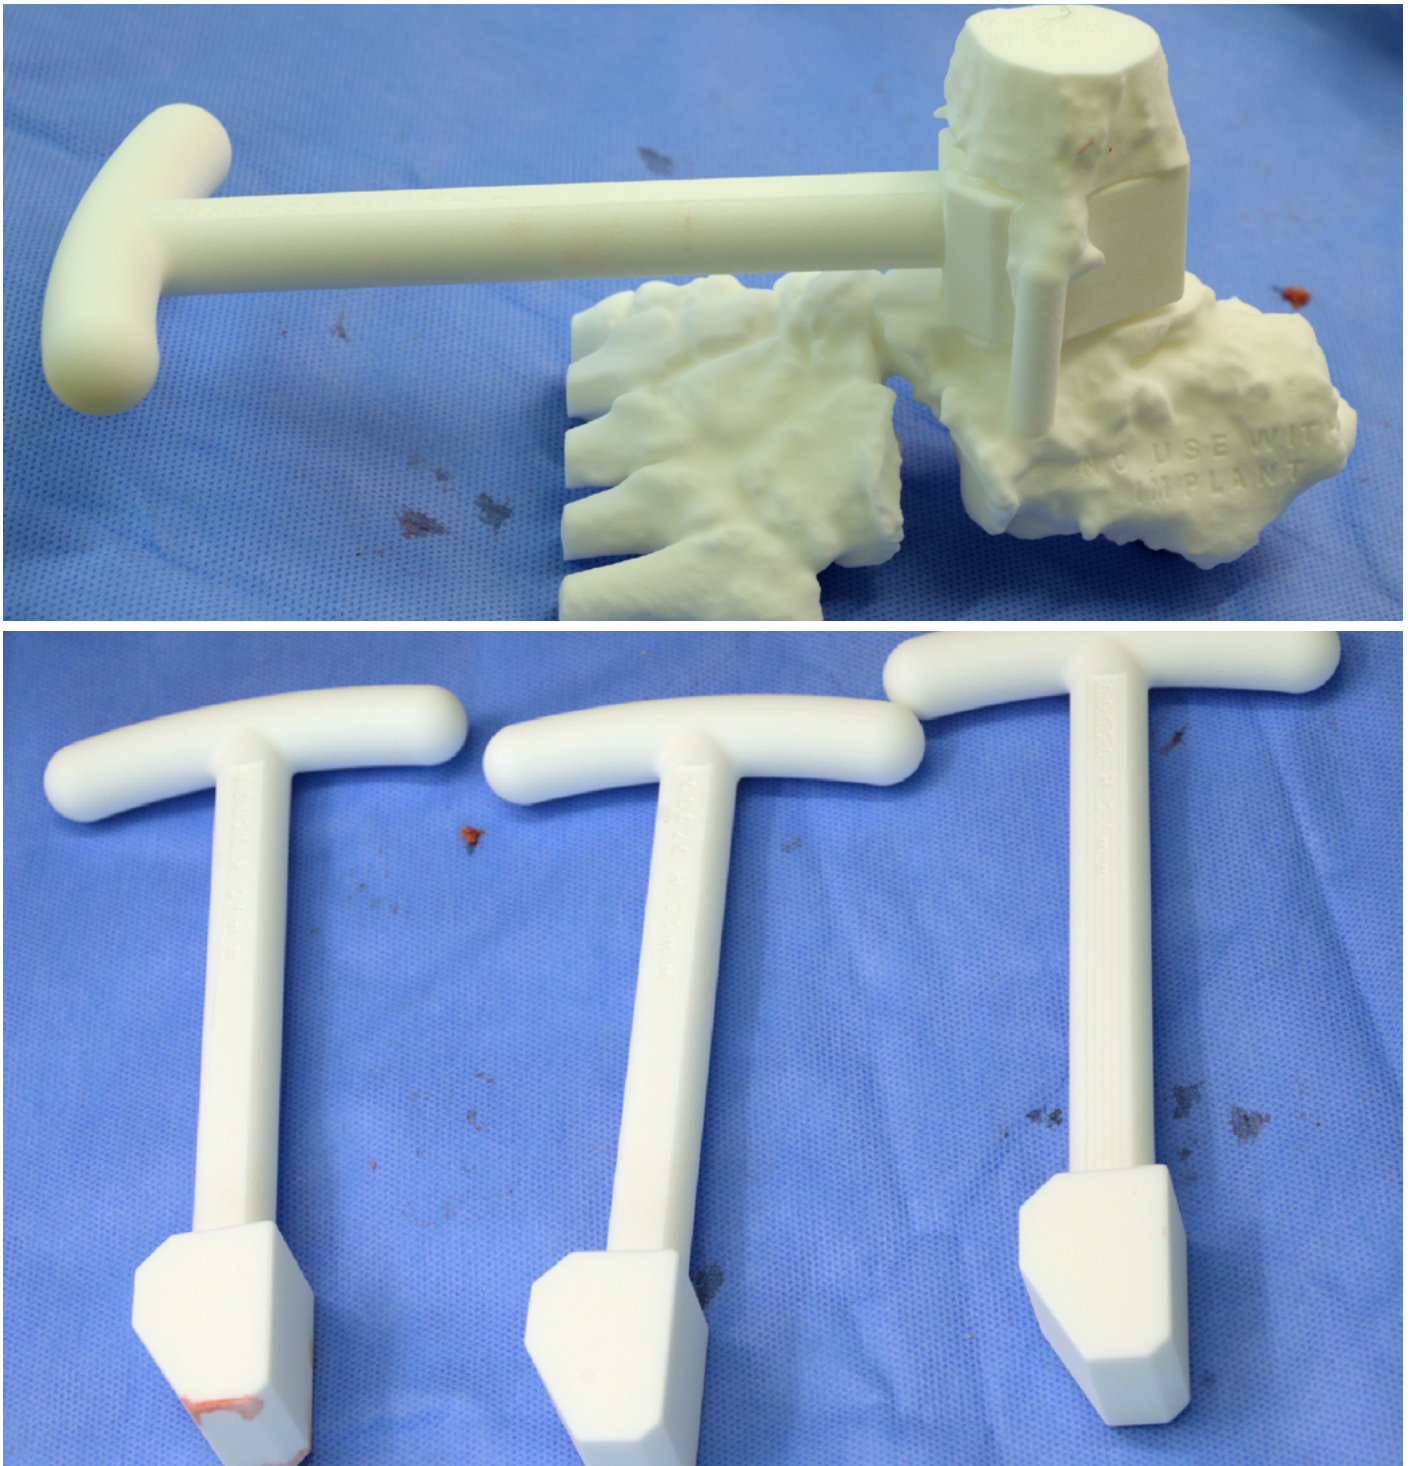
Figure 4 - the plastic model of the void in the foot together with the plastic implant trials.

In order to prepare the void, an intra-operative plastic model was used as a guide to cut fresh flat surfaces to the tibia and talus (in retrospect, the use of custom saw guides would have improved this step). Once prepared the void was then assessed using the plastic sizing jigs to

find the best fit checking to maintain a plantigrade foot (Figures 4 & 5). Once the appropriate size was established, the implant was filled with bone graft and placed in a custom plastic mould to facilitate the application of the Cerement G® [Bonesupport, Lund, Sweden] to the cage (Figure 6). Its changing viscosity can make it difficult to handle and prevent it leaking out of the implant. Once the implant was prepared, it was then placed into the void and secured with the Oxbridge hindfoot arthrodesis nail. The nail was inserted and locked dynamically in the tibia and statically in the calcaneus.

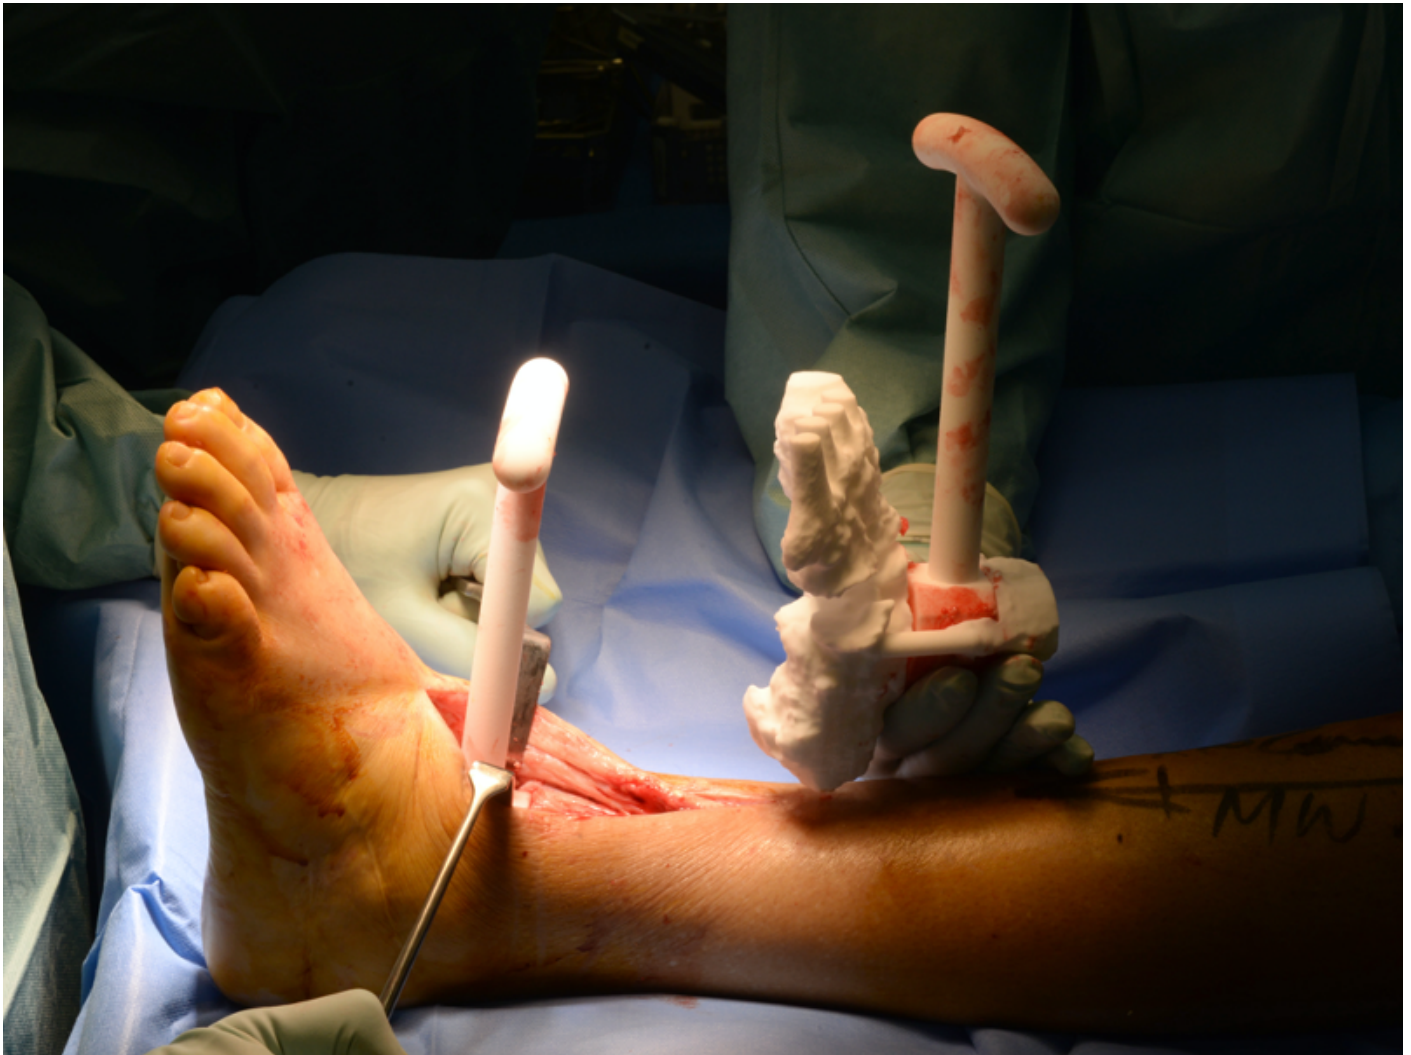
Figure 5 - The models and trials in use

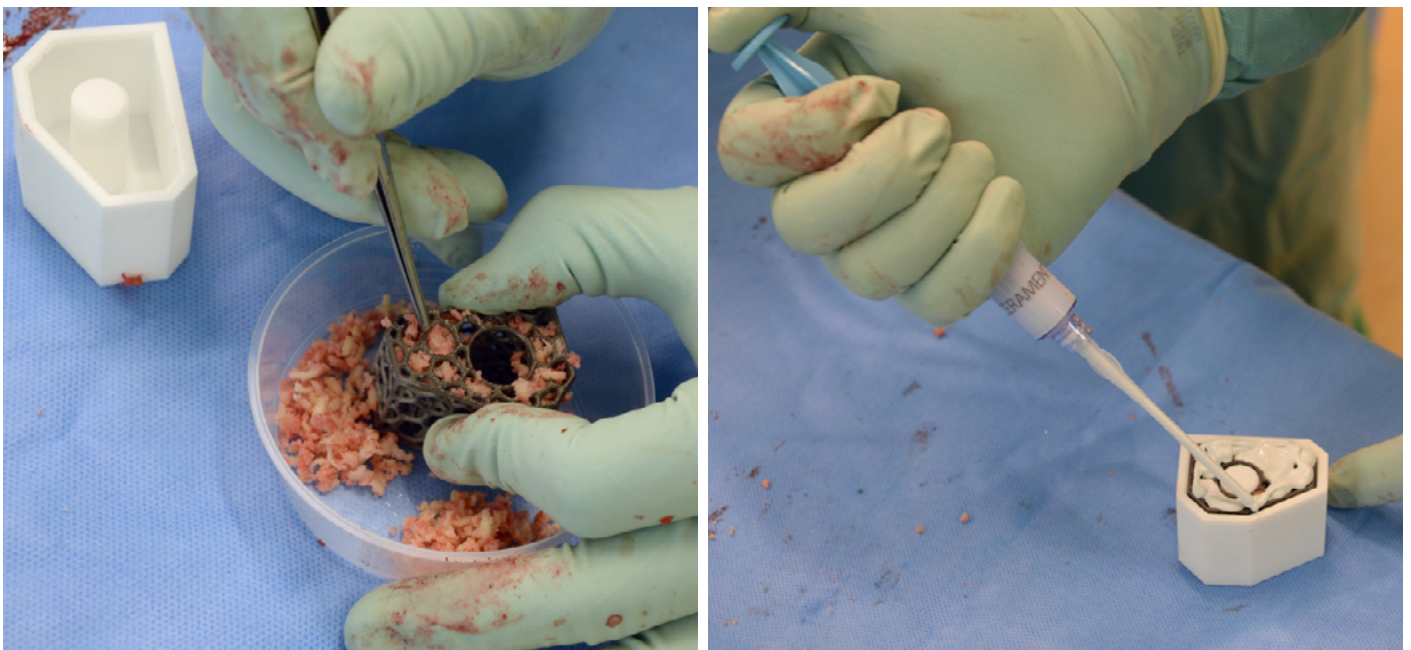
Figure 6 – packing the implant with bone graft and then further filling the interstices with Cerement G® [Bonesupport, Lund, Sweden]

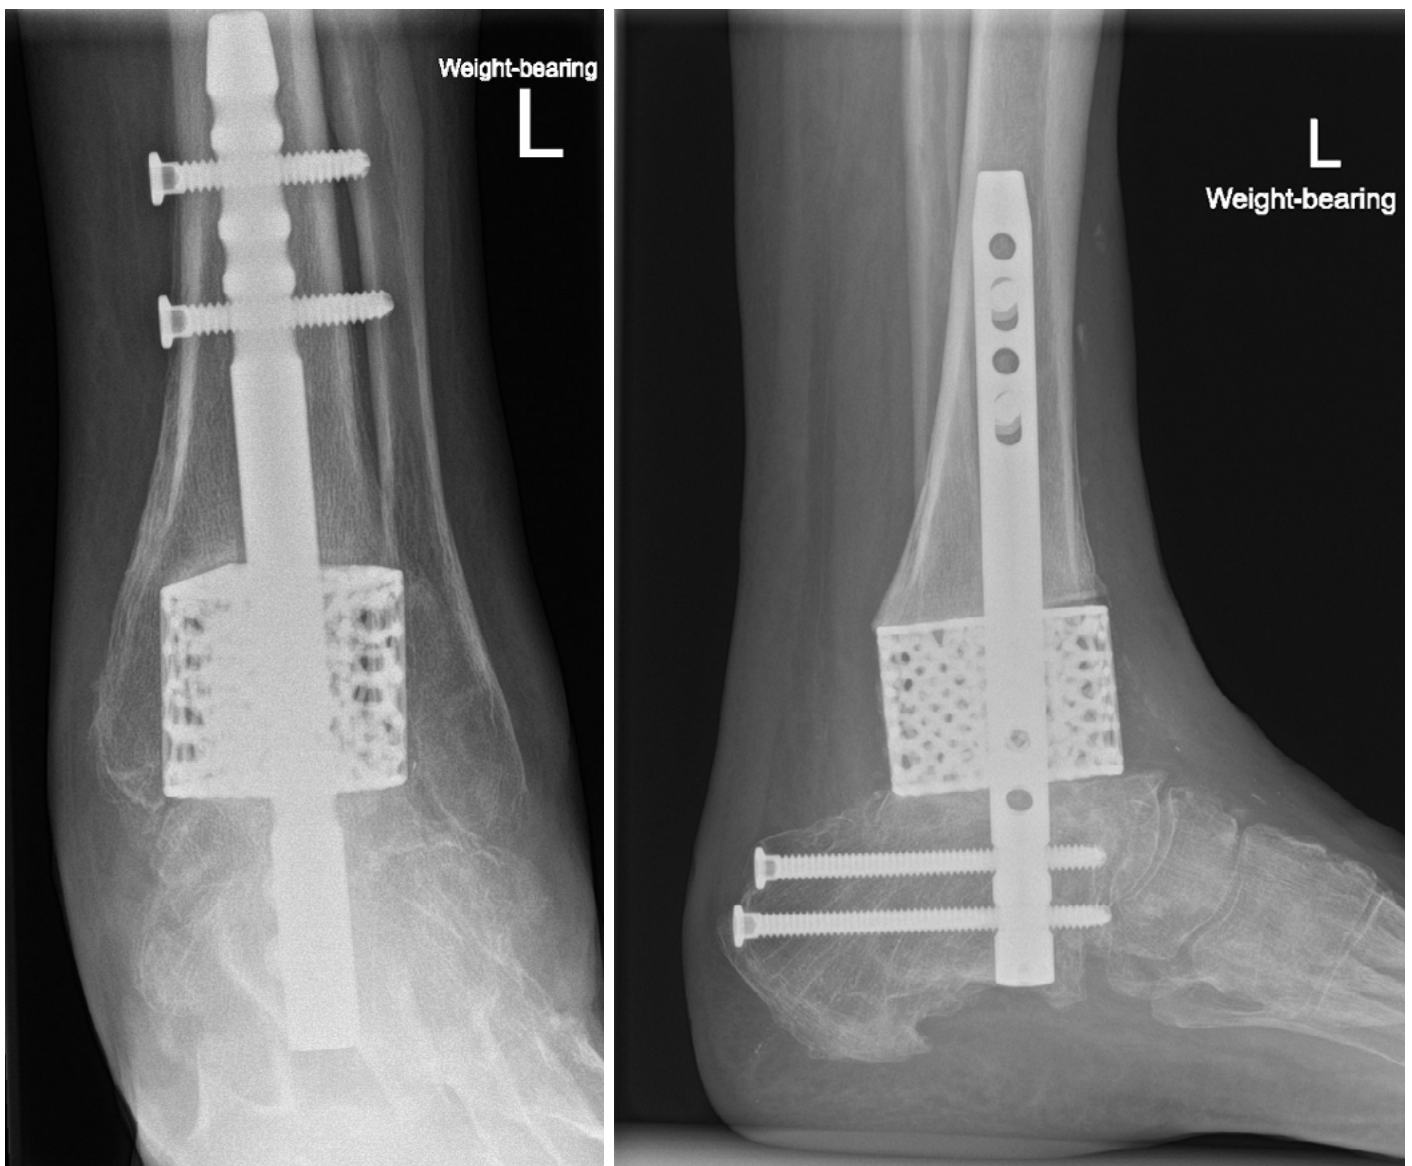
Post-operatively, the leg was rested in a cast for 6 weeks without permitting any weight-bearing. Appropriate thromboprophylaxis was administered during this time. The wounds were checked at 2 weeks and at 6 weeks the patient was allowed to commence bearing weight in a walking boot. The patient was seen in clinic with regular clinical and radiographic assessments. At 6 months of follow-up, the patient has experienced almost 50% of pain relief and improved function as measured by her MOX-FQ scores. She has some residual pain after long periods of bearing weight and on uneven terrain but is the most comfortable she has felt in years. Latest radiographs simply shown that the hindfoot remains well aligned (Figure 7).

Figure 7 - AP and lateral weightbearing views of the implant at 6 months post-op
